Construction Hazards and Risks Control

Lecture Title: – Case Studies in Construction Risk Assessment and Safety Management

**Undergraduate Diploma in
Occupational Health and Safety**

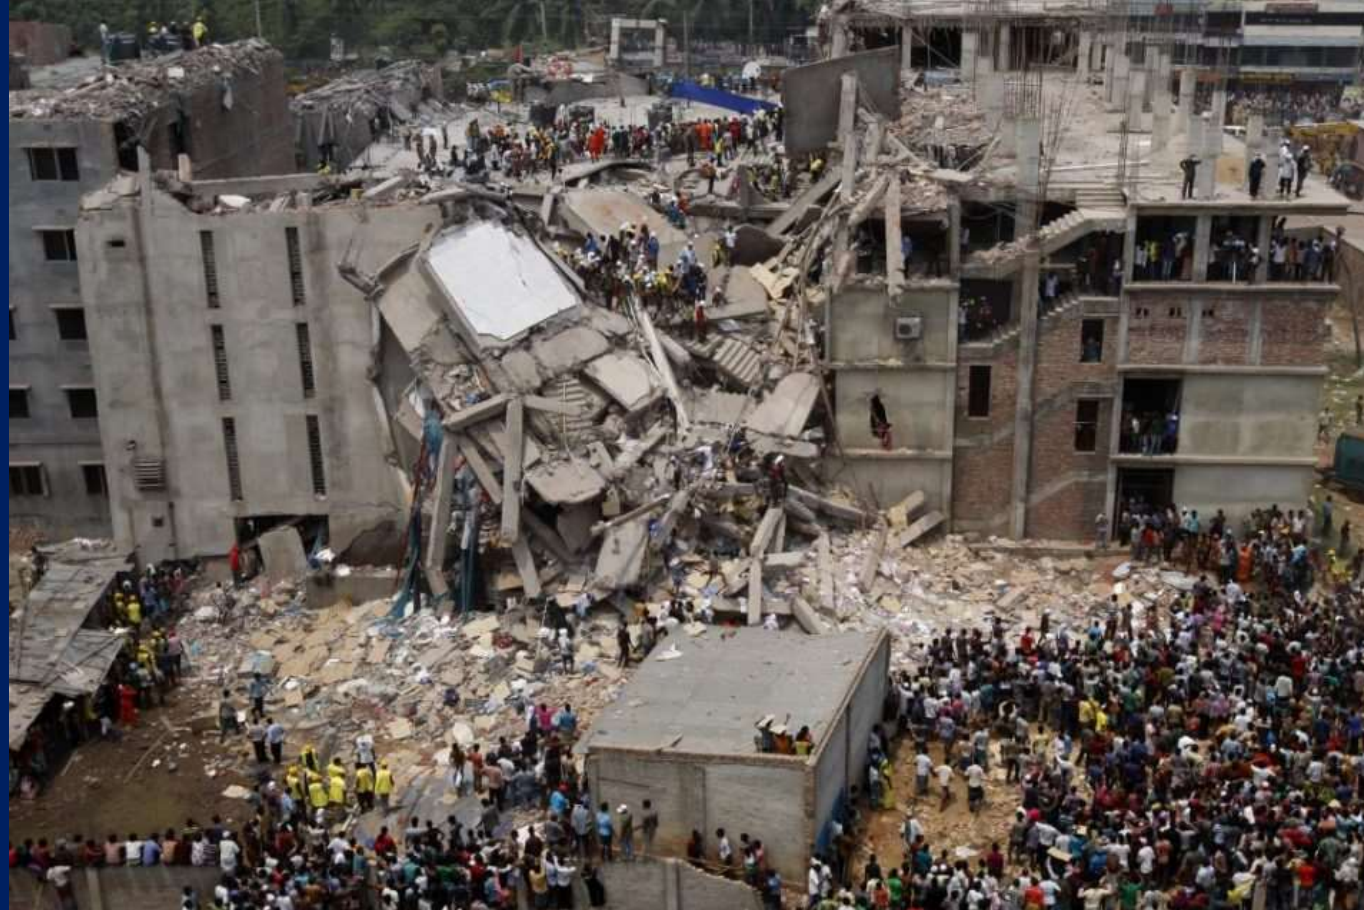
Rana Plaza Building Collapse

- On 24th April 2013, more than 3,000 garment workers in Bangladesh were ordered to go to work in a commercial building that, the day before, had been evacuated due to the discovery of dangerous, structural cracks. During the morning rush hour, the 8-story building collapsed. 1,134 people were killed; thousands more sustained severe, life-altering injuries.

- Rana had secured a permit to build on top of the site of a filled-in pond. He illegally built three stories above the permit and allowed industrial activities in a building constructed for commercial uses. To top it off, he had reassured the public, garment factory managers, and workers that the building was safe on April 23, the day before the collapse, when there were already cracks showing in the building.
- Relatives of the injured and deceased, workers, and politicians in Bangladesh also immediately called for accountability against the powerful garment manufacturers' cartel in the country. But most of the money made on a piece of clothing goes neither to the workers who make it nor to the factory owner in countries like Bangladesh, Vietnam, or Turkey, let alone the owner of the building that houses the factories.
